# **NORTHWEST ENVIRONMENTAL SERVICES, INC.**

Subject: Additional Assessment Report and Site Monitoring Reports:

Former Service Station  
Climbing Hill, Iowa  
Reg. No. 9217516, LUST No. 8LTU14

Woodbury Central Community School District Shop Building  
Climbing Hill, Iowa  
Reg. No. 8811618, LUST No. 7LTV89

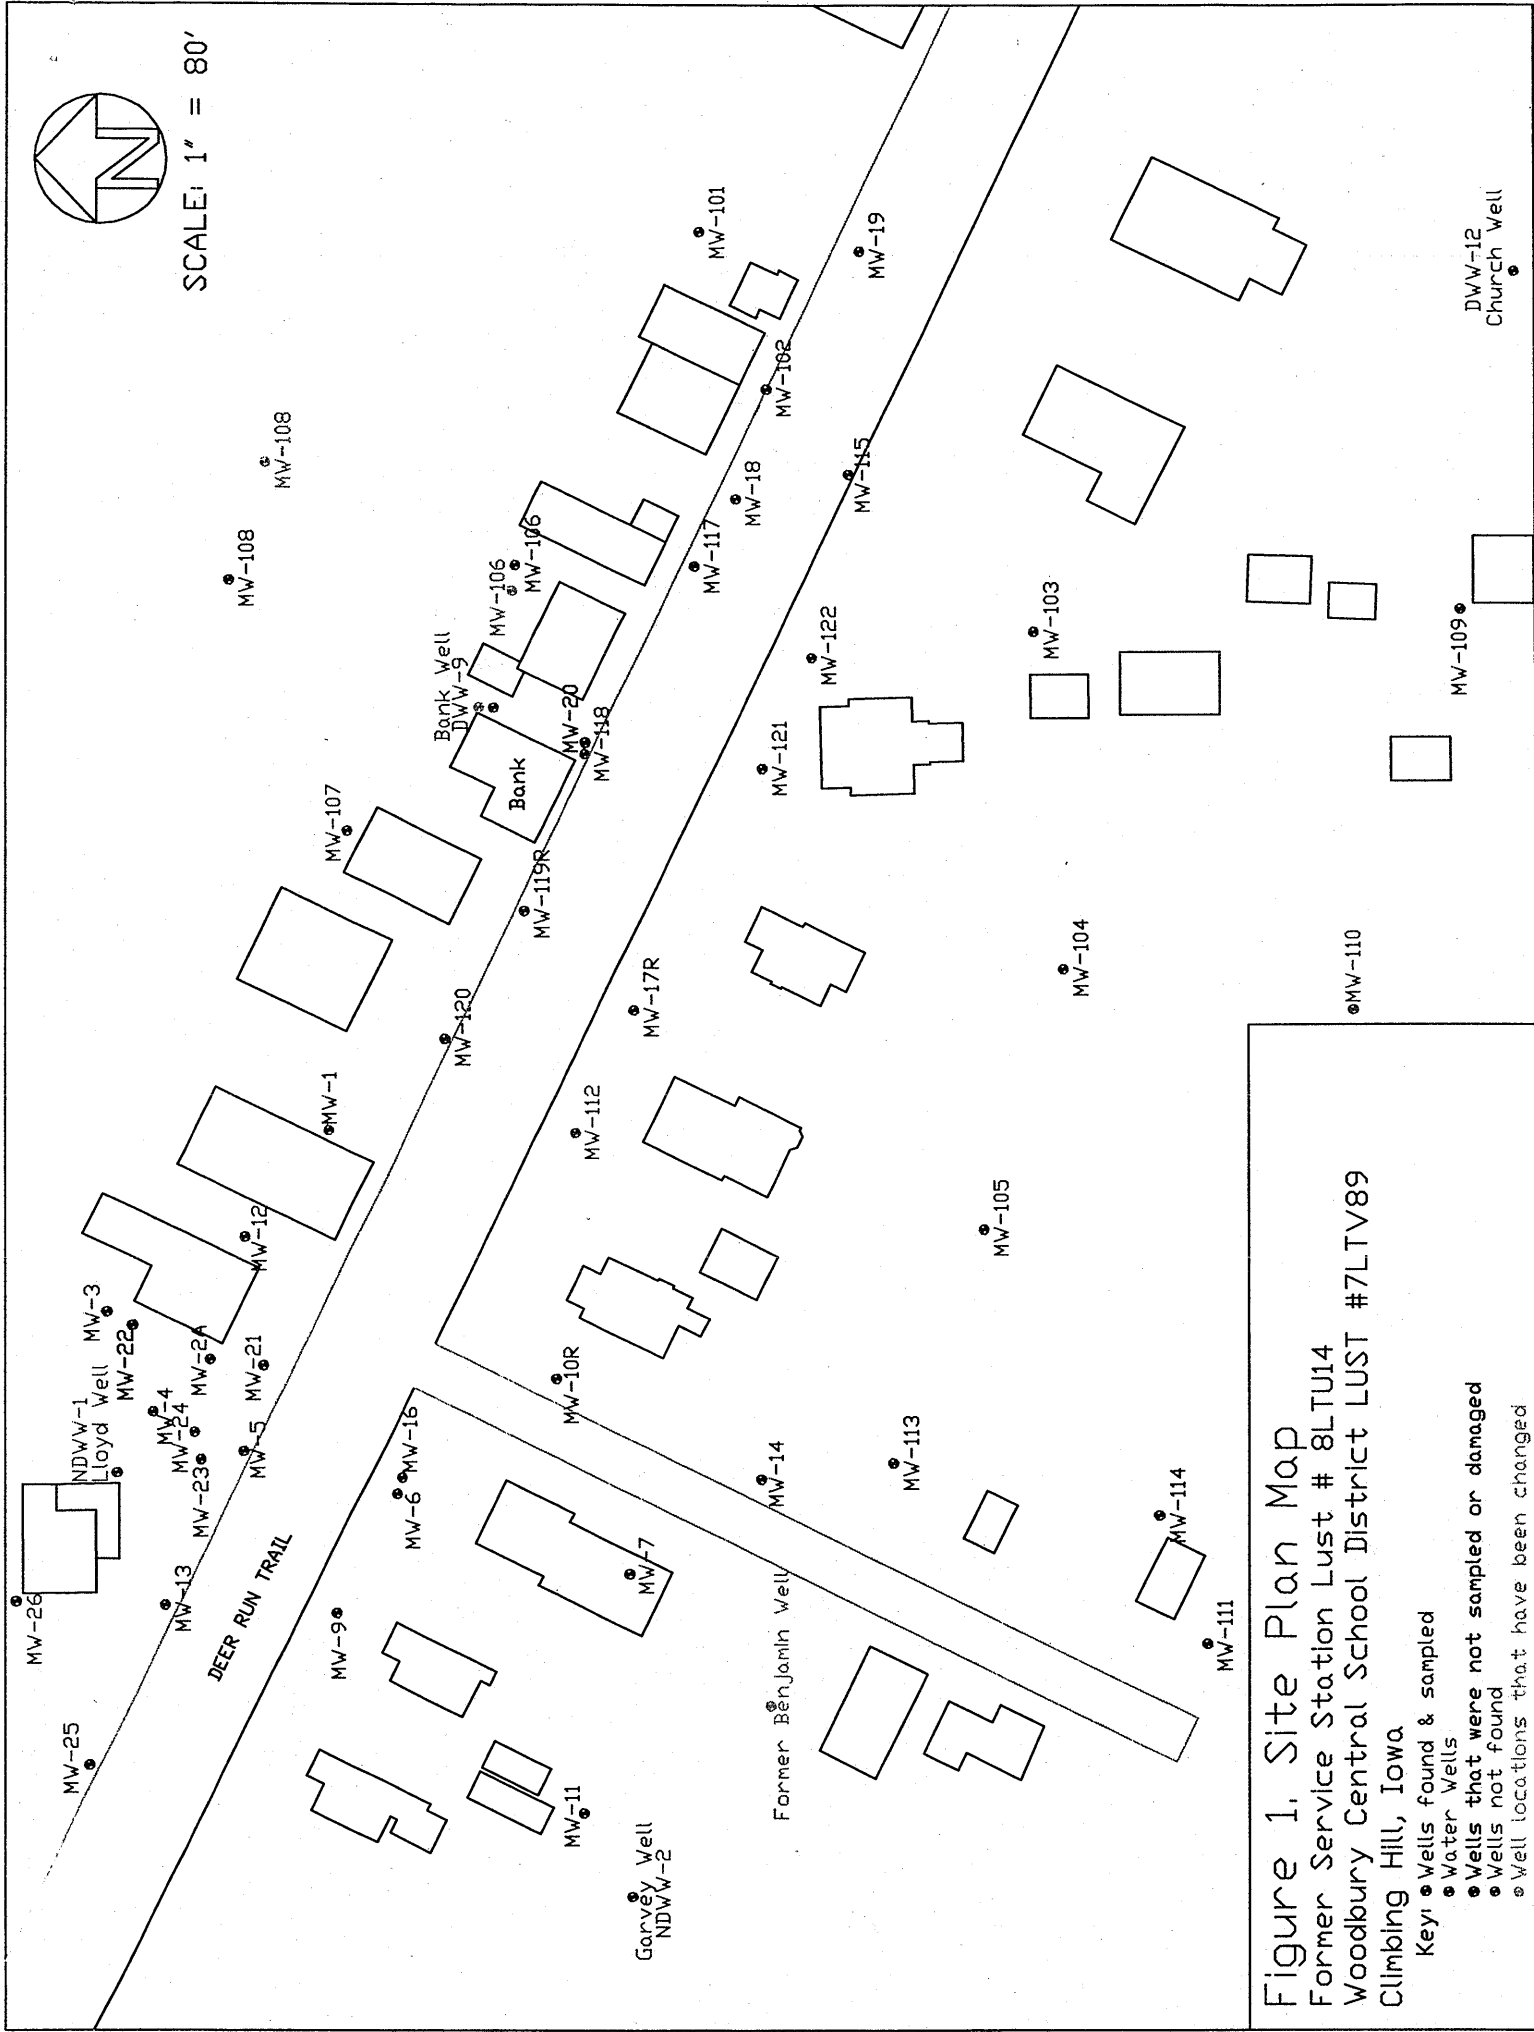
Figure 1. Site Plan Map  
Former Service Station Lust # 8LTU14  
Woodbury Central School District LUST #7LTV89  
Climbing Hill, Iowa

As part of preparing the report for the December 2009 monitoring event, the site plan map was recreated using maps in our files, copies of maps provided by the IDNR, aerial photography, and actual onsite measurements. Corrections to well locations were made as necessary and include corrections to the x,y-coordinates in the Tier 2 software. The corrections to the x,y-coordinates are illustrated on the site plan map by showing the original locations in grey and the corrected locations in red. This report includes additional corrections to building dimensions and locations and the x,y-coordinates of wells including a significant correction to the location of MW-108 based on actual onsite measurements.

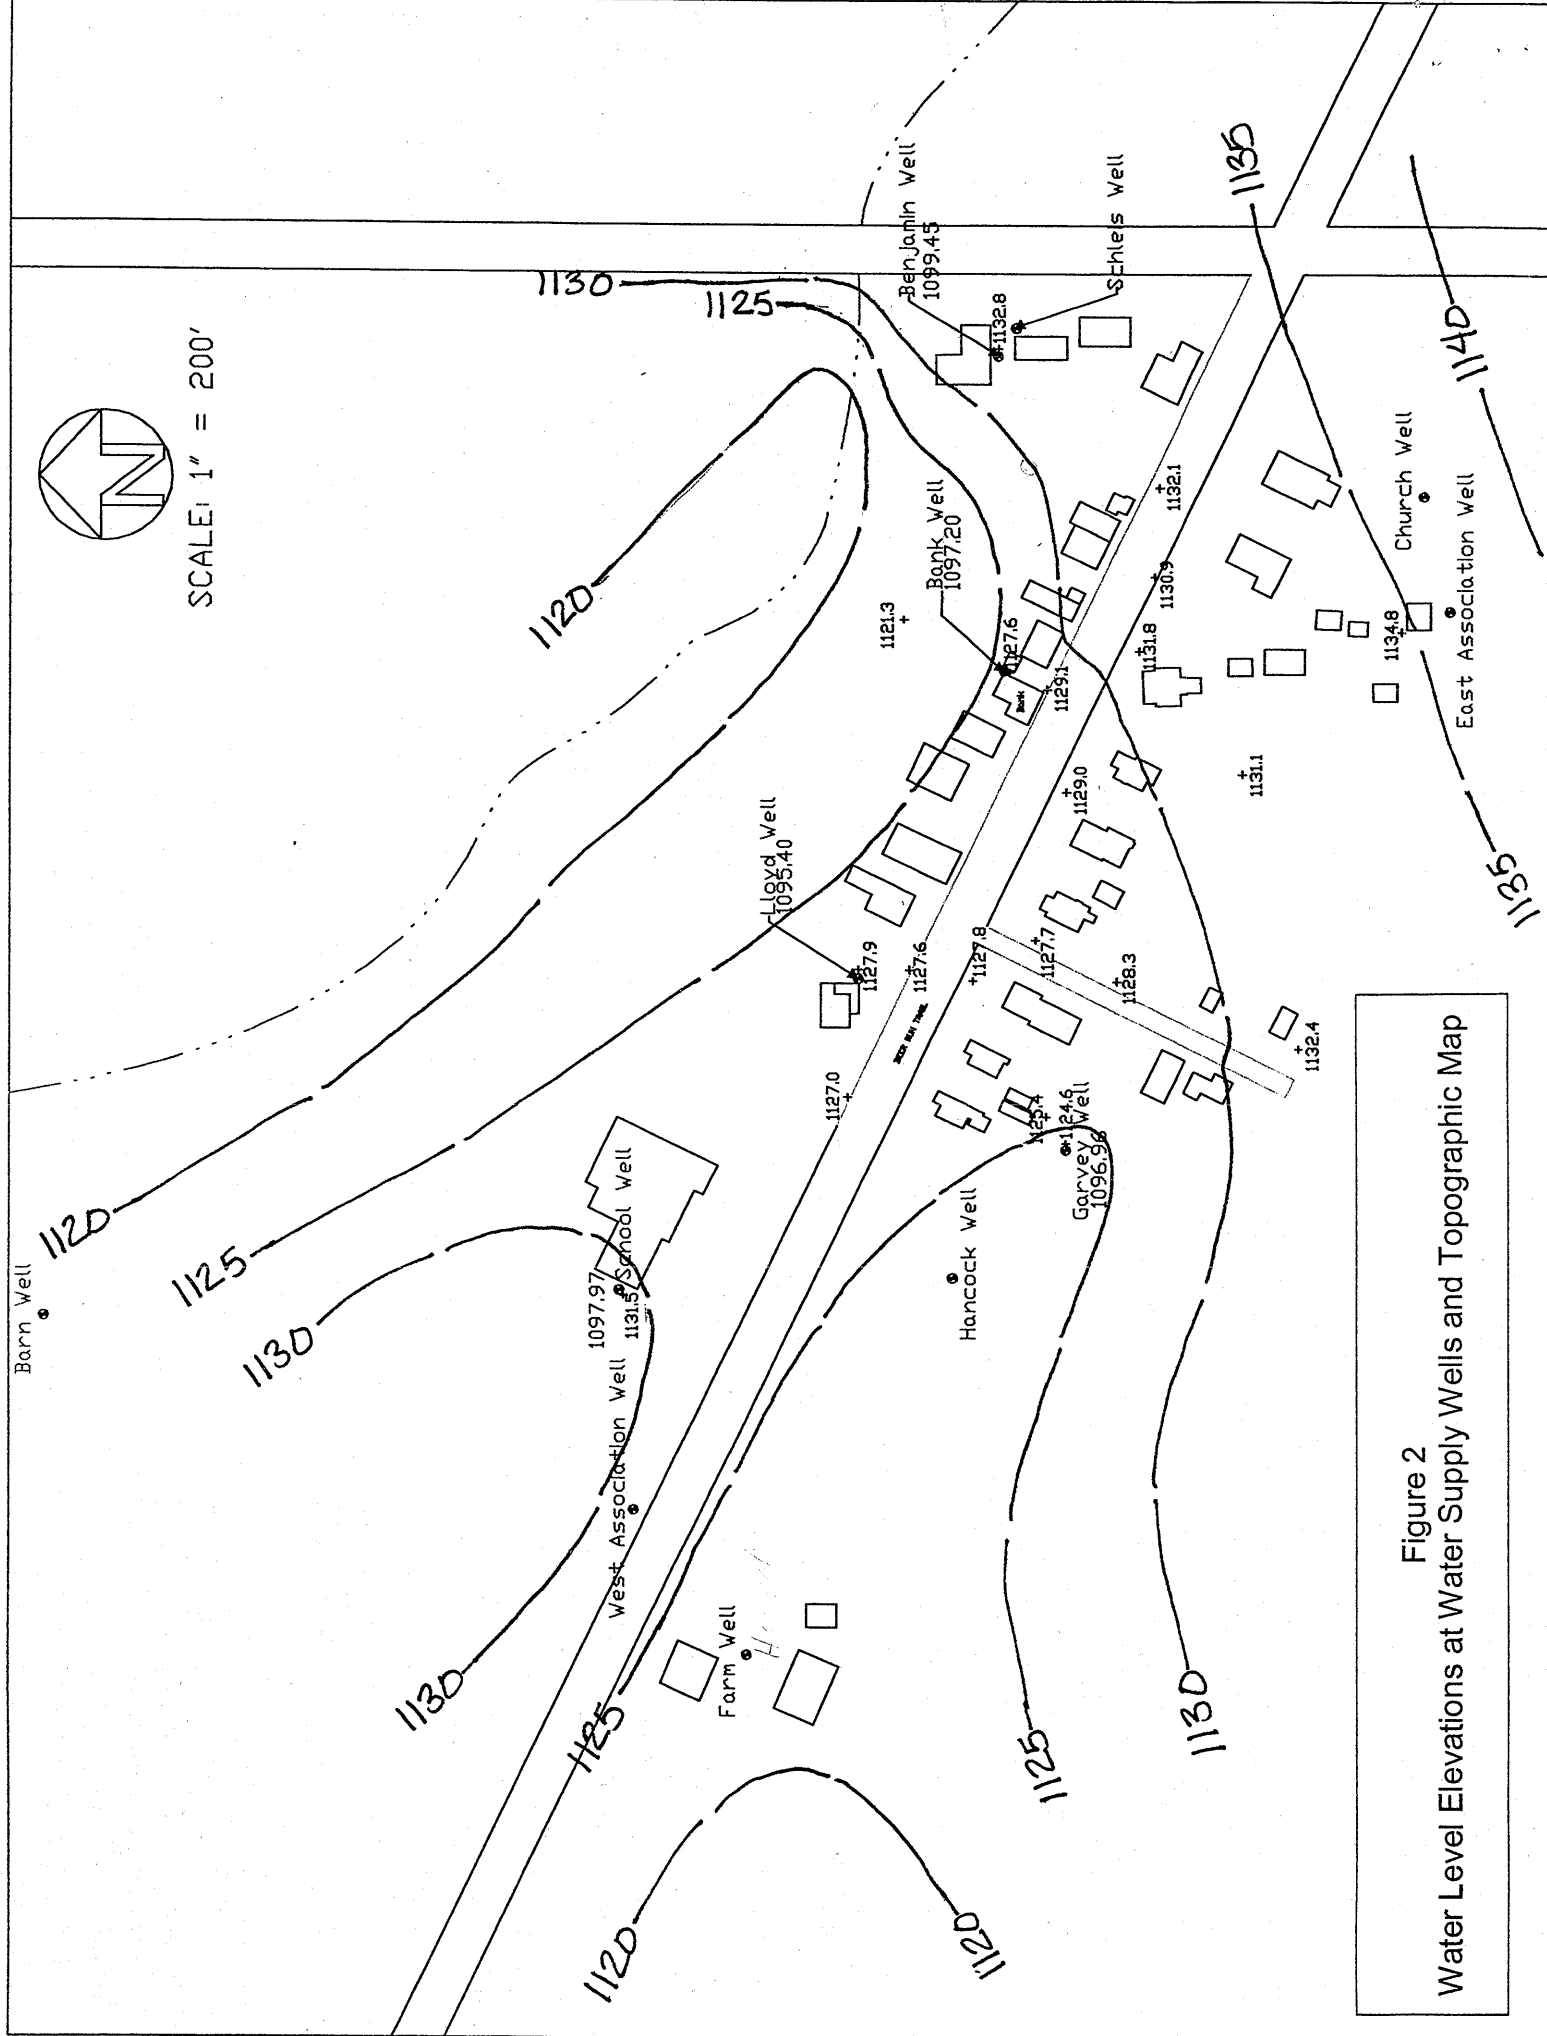
Figure 2  
Water Level Elevations at Water Supply Wells and Topographic Map

The water level and elevation survey results for the water supply wells are provided in Table 4. Because the owners of the Schlies and farm wells did not allow access and because the well design of the Church and Hancock wells prevented access, only five water supply wells were surveyed. The water elevations at these five wells are shown on a topographic map provided as Figure 2. The water elevations in the water supply wells appear to generally correspond to the land surface elevation. For example, the land elevations at the Benjamin and School wells are the highest with the corresponding two highest water elevations. The School well is located on a slight hilltop. A comparison of the elevations between the Garvey and Lloyd wells indicate that this correlation is only approximate.

The lack of data from the Church, Hancock, and farm wells greatly limits the data set. If water elevations were available for these three wells, we anticipate that the water elevation in the Church well would be similar to the Benjamin well and the water elevations would be lowest in the Hancock and either of the farm wells. The relative water levels at the Garvey and Lloyd wells do not fit this pattern. This pattern generally follows the direction of groundwater flow at the water table where monitoring wells are present. Because monitoring wells are not located near the School well, shallow groundwater flow direction near the School well is uncertain. It should be noted that the Bank well is 40 to 50 feet deeper than the other wells with known depths and this well is completed in Dakota sandstone.

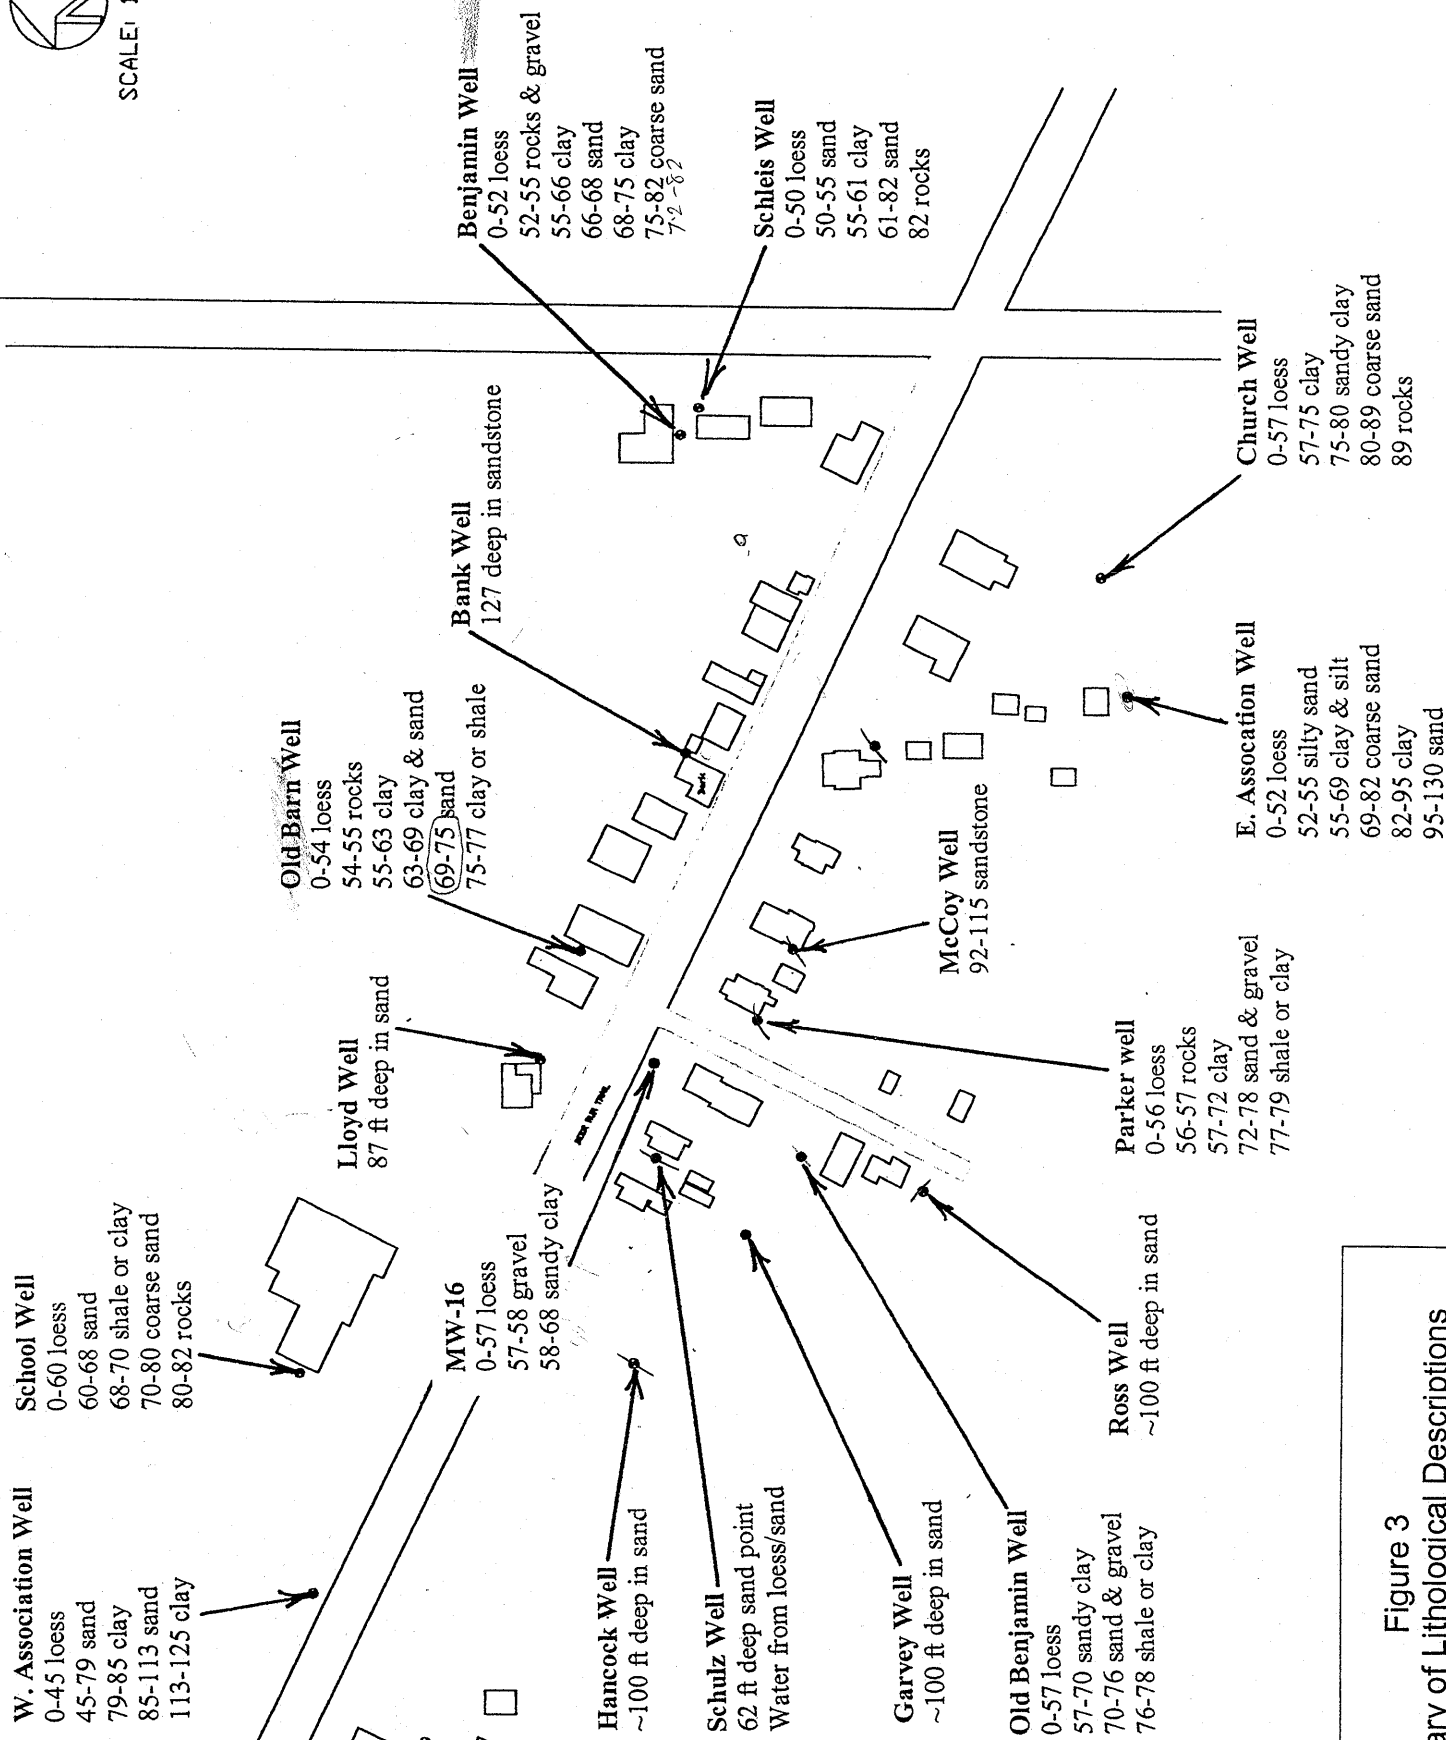
Figure 3  
Summary of Lithological Descriptions

The geologic information is summarized in Figure 3. A review of these descriptions indicate that old Benjamin well, the old Barn well, and the Parker well do not appear to have penetrated the alluvial aquifer above the Dakota Formation. For example, at the old Barn well gray sand was noted between 69 feet and 75 feet, however, gray clay and shale underlies this sand. The gray sand may have been localized sand deposits associated with the glacial till and most of the water produced by the well may have originated from the coarse alluvial layer indicated as rocks at 55 feet. If the water production from the well appeared limited, the filter pack was likely extended upward through the coarse alluvial layer.
